**HALTEMPRICE PRIORY FARMHOUSE**  
**ABBAY LANE**  
**WILLERBY, HULL HU10 6ER**

**Grade II\* Listed building**  
**Scheduled Ancient Monument SM 32639**  
**Proposed re-instatement as a single domestic dwelling**

**PLANNING, HERITAGE,**  
**DESIGN AND ACCESS STATEMENT (PHDAS)**

**September 2011**

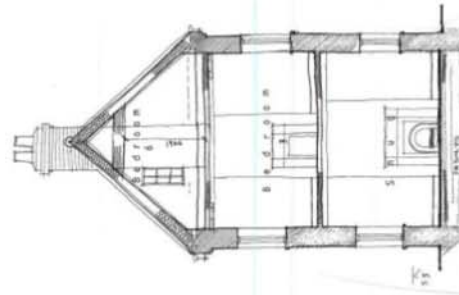
SECTION E - E

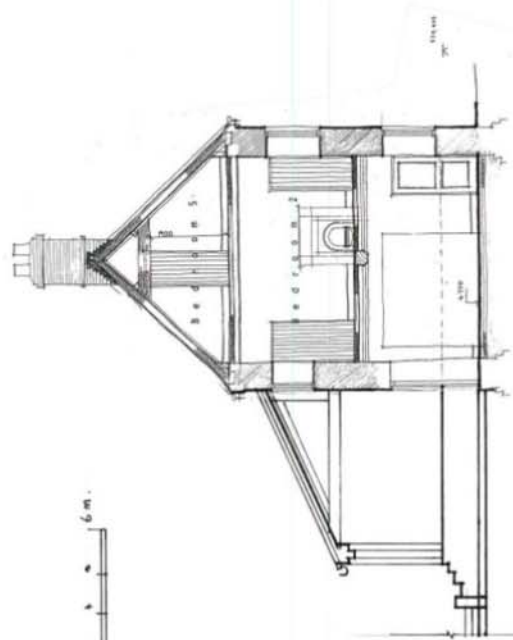
SECTION A - A

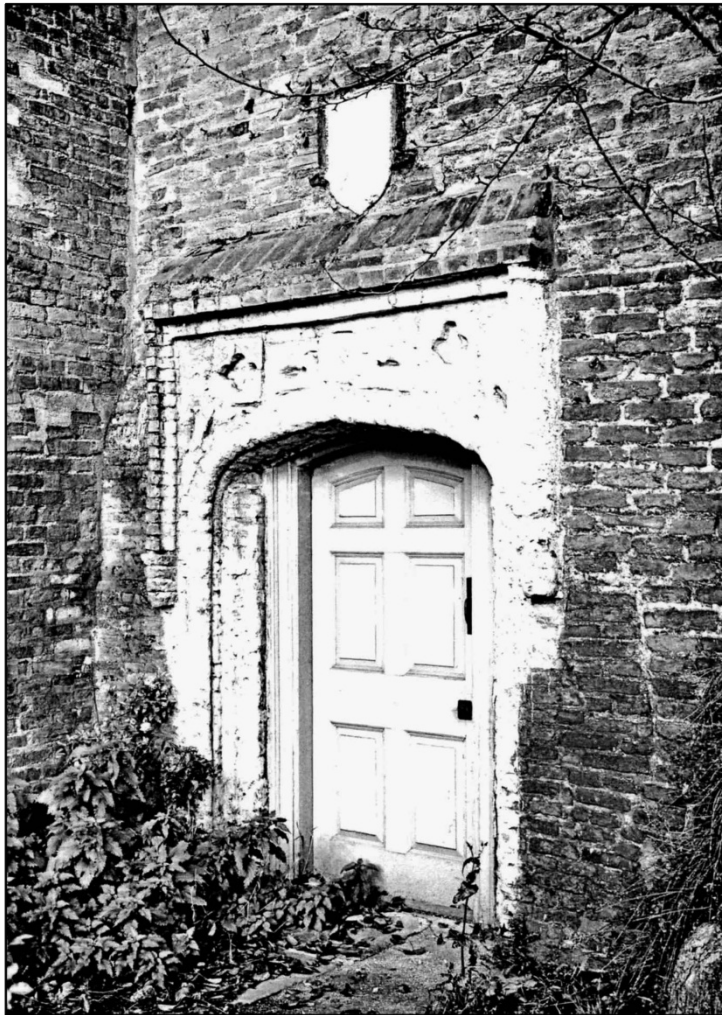
Plate 4: View of south doorway, November 1975 (© Crown copyright NMR BB77/7966)

There was formerly a panel over the moulded doorway arch, bearing quatrefoils with a deeply moulded foliage ornament to each segment, flanking other pierced and shaped motifs in the panel's centre; all decorative work was carried out in brick (Hall 1976, 27-28). Photographs taken in 1975 show that the panel decoration was thickly rendered and/or painted (NMR photo BB77/7967; see plate 7). The panel was surmounted by a chamfered brick hood with sides descending to corbelled (?) or moulded brick stops (Anon c.1980; Pevsner & Neave 1995, 756). Above the doorway was a stone shield bearing a design and the date 1584 pierced by a heart, again surmounted by a hoodmould (Boutell 1889, 71) (see figure 9 and plate 7). The *azure fretty argent* design (NMR photo BB77/7967) bears a striking similarity to the arms of the Stutville family, medieval lords of Cottingham, but they actually belong to a branch of the Ellerker family which are depicted by Hall (1892, 192); the arms would have had a blue background with the fretty in silver and a silver band across the top (David Neave, *pers. comm.*); this design is quartered with those of Bradshaws in a c.1700 depiction of a later house at Risby (Neave & Turnbull 1992, 56). It is suggested in several previous studies that the shield has been inserted (e.g. RCHME 1992). The 1584 date was no longer clearly legible by 1992 and since then both the shield and much of the panel below have been removed, although parts are believed to be stored somewhere in Hull (Mike Hadgraft, *pers. comm.*); it is now not possible to determine whether the shield was inserted or not. The doorway retained a door with a four-centred arched head and six raised and fielded panels in 1975 (NMR photo BB77/7966; see plate 4).

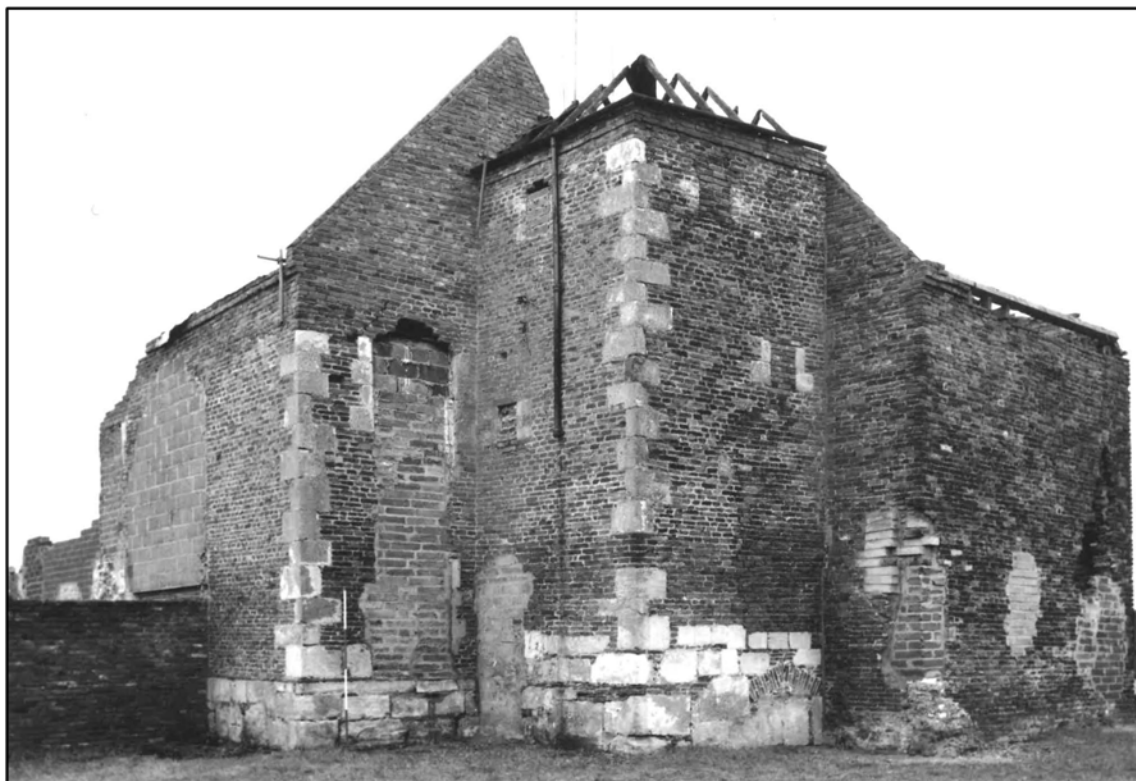
Plate 5: West side of farmhouse showing stair-tower, looking south-east, January 2004 (photo 1/8)

Elevation 6 forms the west wall of the stair-tower at the west end of the farmhouse (1/6 and 1/8). At the base of the wall, the excavation of Test Pit 3 revealed the truncated remains of a brick-built culvert (see Chapter 5 below), which passed through the wall and appeared to be contemporary with its construction (see plates 10 and 23). Above the culvert, the base of the wall is made of re-used pieces of dressed limestone, some of which have chamfered edges and which are up to 1m in length; one bears the very eroded inscription “IVY 1944”. There is some brickwork between the stone pieces, with average dimensions of 240mm by ? by 35mm. Directly over the culvert, the limestone incorporates a pointed brick arch, apparently acting as a relieving arch for the culvert (NMR photo BB77/7976) (4/19); the bricks varying from 45mm to 70mm in depth. Above the level of the relieving arch, the limestone pieces become smaller and are then replaced by brickwork, although they continue as quoins for almost the full height of the elevation. There is a “missing” quoin at approximately the same height as a slight offset or horizontal joint on the north wall of the stair-tower (see elevation 7 and plate 5).

Elevation 8 represents the north end of the west gable of the main house (1/7 and 1/8; see plate 5). As with the adjacent elevation (elevation 7), the wall rises from a roughly chamfered plinth of re-used limestone pieces (4/21). Above the plinth, the limestone continues as quoins to the brickwork, but these stop short of the eaves (4/31); one of the lower quoins appears to bear a shallowly incised cross. The central part of the elevation contains a large area of breeze-block repair, which obscures the remains of two windows. Both have limestone jambs; the lower window retains the remains of a moulded stepped architrave (4/22). Photographs taken before the breeze-blocks were inserted show the lower window head to have comprised a single piece of limestone formed by a stepped architrave over two rather flattened pointed arches of 15th century appearance with incised spandrels (NMR photos BB77/7974-75; see plate 11). The detail of the brick blocking suggests that the window was originally of two lights. The upper window was fitted with a two-light casement, each casement having six large panes; this window was inserted into a slightly wider and higher opening which retained its limestone jambs. There also appears to be a ragged joint in the brickwork running between the windows. The upper part of the gable was rebuilt in 1994 (Gelder & Kitchen 1992-93).

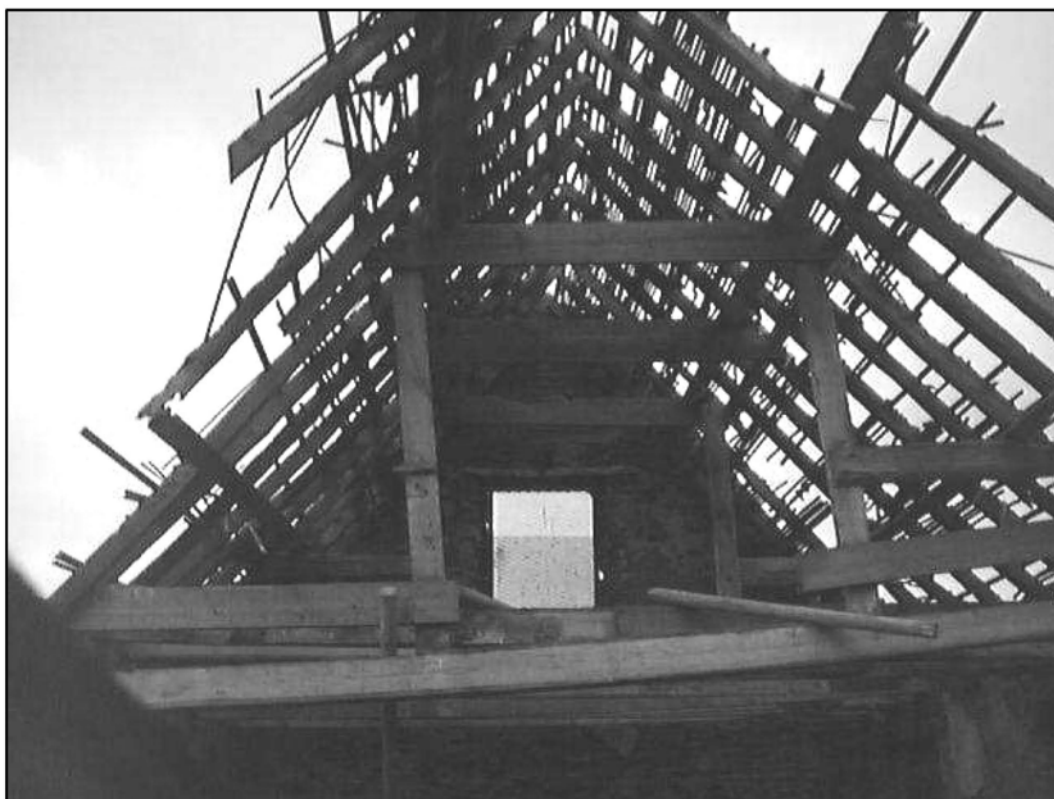
Plate 6: Roof structure over main range, c.2000 (Hadgraft collection)

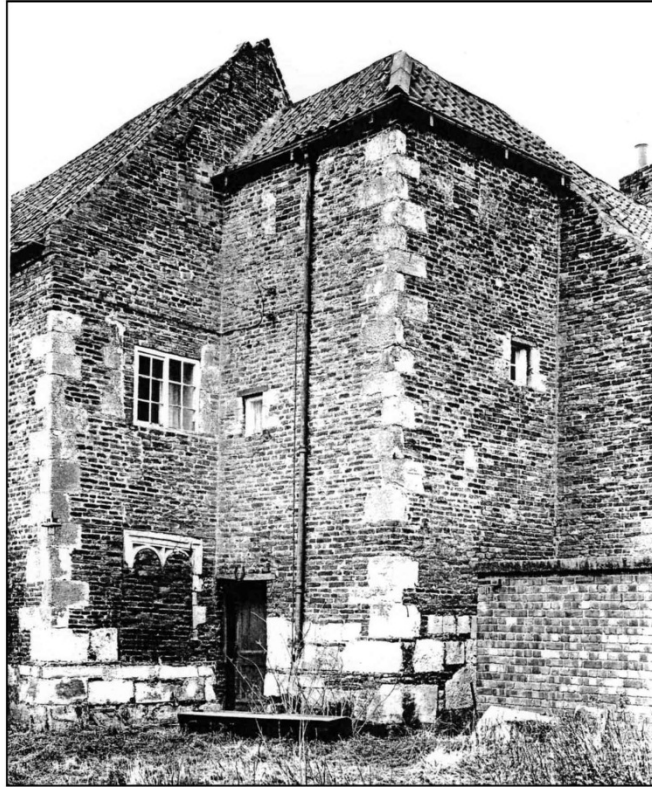
Plate 11: Stair-tower, looking south-east, November 1975 (© Crown Copyright NMR BB77/7974)

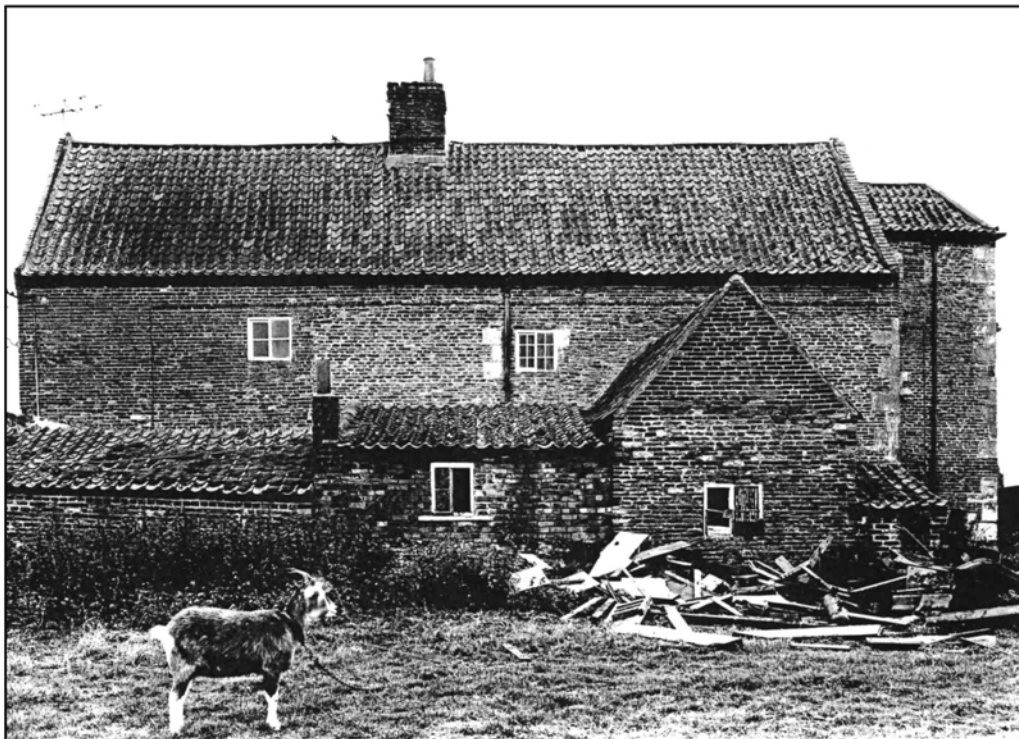
Plate 12: North side of farmhouse, looking south, November 1975 (© Crown Copyright NMR BB77/7969)

Photographs taken in 1975 (NMR photos BB77/7970 & 7972) show the northwest wing to have been brick built and of a single storey with a relatively steeply-pitched pantiled roof (see plate 12); it was in use as a pantry in 1974 (Hutton 1974). A small window is visible in the north gable; the upper part of the gable appears to be of a different brickwork to that below, and may have been a later addition or alteration. If so, it was rebuilt again in 1994 (Gelder and Kitchen 1992-93). There was a small brick lean-to structure with a sloping pantiled roof formerly located against the west wall of the wing, and a doorway at the south end of the east wall. A single storey lean-to with a small stack once butted the north end of the east wall, and this had an even lower lean-to on its west side running off to the east; both had pantiled roofs (NMR photo BB77/7969). A boundary wall once ran south from the east end of the lower lean-to, essentially creating a small courtyard at the rear of the main house (Gelder and Kitchen 1992-93). A number of derelict wooden sheds are shown at the north-east corner of the courtyard in a photograph of c.1985 (Hadgraft collection). During clearance works undertaken to the rear of the farmhouse, the brick floor of the former north-west wing was exposed (4/2 and 4/3) (see figure 22).

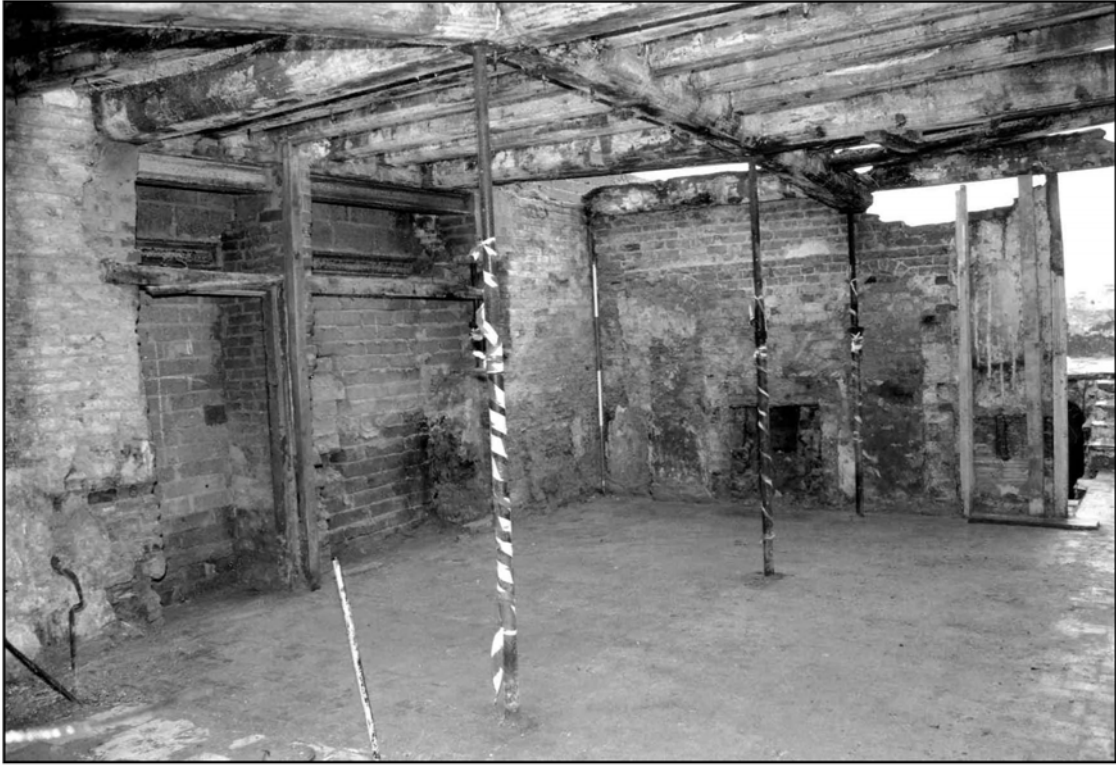
Plate 17: Ground floor main room after clearance, showing fireplaces in north and east walls, looking north-east, February 2004 (photo 3/17)

There was clearly once also a large fireplace in the north wall of the main house (elevation 17), served by a large exterior lateral stack although very little now survives. On the ground floor, only the eastern chamfered brick jamb is still evident, and now forms one side of a 2.90m wide blocked opening (3/17 and 3/18; see plate 17). The opening was originally created during the building of the north-west wing, then blocked using breeze-blocks and a steel beam when it was demolished. The creation of the north-west wing obviously required the demolition of most of the external lateral stack, although some remnants of the side of the original flue are visible when looking upwards from the interior of the blocked opening. The blocked opening is flanked by blank wall to both sides. The lower 0.80m of the wall is of coursed squared chalk, whilst the upper part is of brickwork. This brickwork incorporates many late medieval bricks, although some are also comparable to those found in extant late 18th century East Riding buildings (Tibbles 2004).

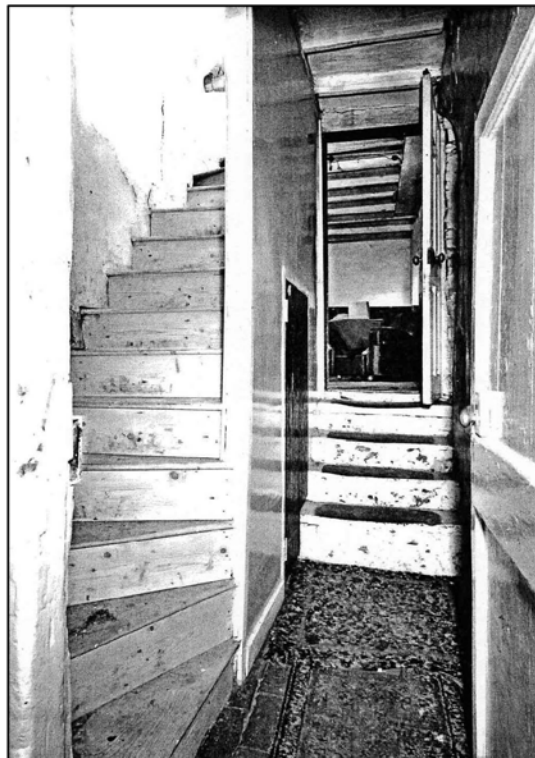
Plate 18: Arrangement of stairs leading to east end of main range, November 1975  
(© Crown Copyright NMR BB77/7977)

The east end of the main house was substantially raised when the cellar was inserted and the ground floor here is set 0.80m above that of the main room to the west (see elevation 17). The raised east end of the ground floor is now accessed via a flight of brick steps set against the south wall of the house (4/13 and 4/15), but there was formerly also a parallel wooden staircase set at the south-west corner of the central stack rising to the first floor and then the attic (NMR photo BB77/7977; Gelder & Kitchen 1992-1993) (see plate 18). The north (4/6), south (3/43) and east (3/4) internal elevations of the east end (elevations 17, 11 and 20 respectively) are substantially the same as the external faces (see above) and so no further description is given here; much of the internal brickwork contains bricks of probable 18th / 19th century date (Tibbles 2004).
